# HOME INSPECTION REPORT

## Recommended Periodic Home Maintenance Schedule

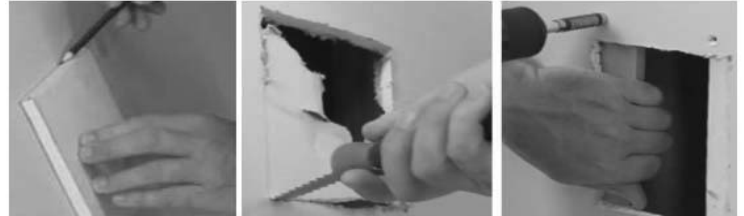
### Patching a large hole

Cut a drywall patch. Place it over the damaged area to trace it. Cut along your lines with a dry-wall saw or by making repeated passes with a utility knife.

Remove the damaged piece and clean up the cut with a utility knife. Bridge the back of the opening with a board 4 inches longer than the opening. Secure the board to the drywall and to the patch to the board with screws. Apply joint tape by covering the seams with a thin layer of joint compound, press the paper into the compound and smooth it by drawing a clean putty knife across it with firm pressure. If you're using adhesive-backed fiberglass tape, just press it onto the drywall seams. When the first coat is dry, scrape off any dry bits on the surface and apply a second and third coat.

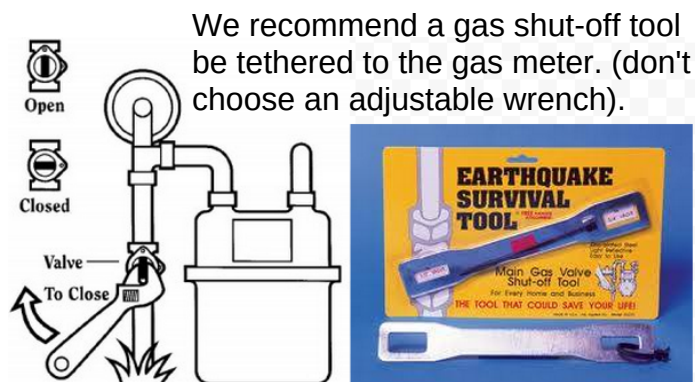
### Gas shutoff video demonstration

We recommend a gas shut-off tool be tethered to the gas meter. (don't choose an adjustable wrench).
